Tea Staining

on Stainless Steel Surfaces

Authors: Barry Walker, Don Thornton & Simon Griffiths

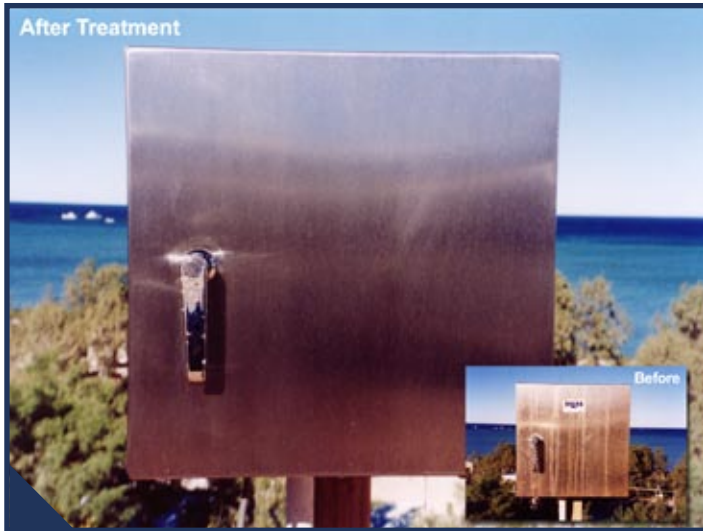
Figure 5 - Showing tea staining after treatment

Typical examples of applications both before and a significant time after coating applications are shown in figures 5 and 6.

Coating Before coating can take place the surfaces must be thoroughly cleaned. If the metal has already experienced some tea staining then this must be removed with a suitable deoxidant such as a 2% solution of phosphoric acid (care should be taken to follow the manufacturers instructions when diluting and applying phosphoric acid). This is also safe for exposure to typical gasket materials. After leaving the deoxidant for a few minutes, some 'elbow grease' also needs to be applied, and the surface rubbed with a non-metallic cleaning pad in the direction of the grain of the material. Do not rub across the grain as this will burr the polish lines and dull the surface. Generally after this process there should be no oxide stains visible on the metal surface.

The next step in the coating process is to ensure that any traces of the deoxidant are removed by rinsing with fresh water, cleaning the metal with a cloth, then repeating the process again. Ensure that the surface being cleaned is completely dry before proceeding to the next step.

The final step is a coating of a readily available clear nylonic polymeric resin such as Nycote. This can be purchased directly from B&R or from a reputable supplier. This coating is easy to apply, and is dry to the touch in 15 minutes, and suitable for handling in 1 hour (at 27°C).

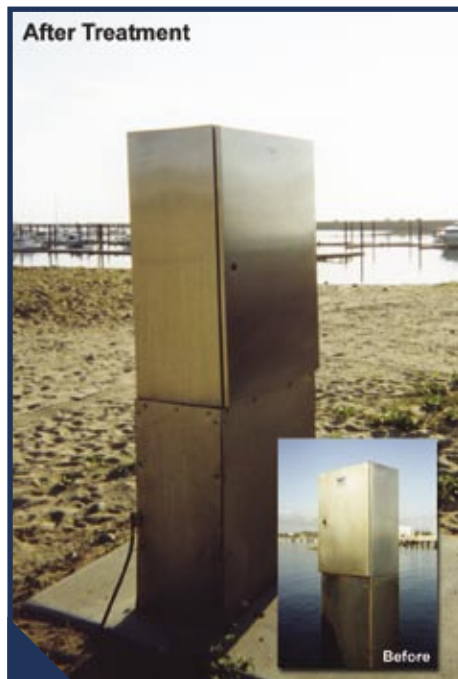
Figure 6 - Showing tea staining after treatment
